I-36 Hull Restoration

09 March – 19 June 2015

This article documents the events of a four month long effort to sand, repair, and paint the keel and hull of a 1978 Islander 36 sailboat.

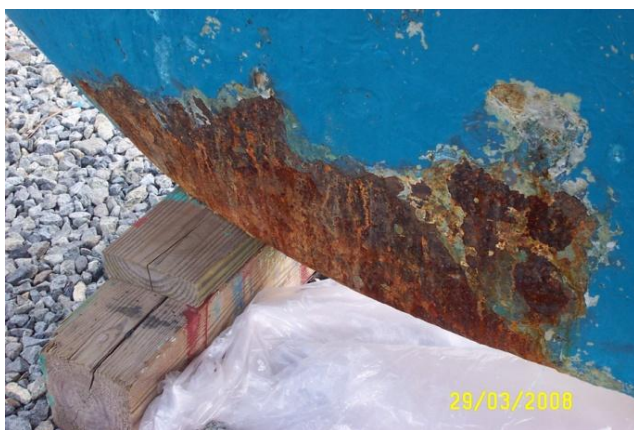
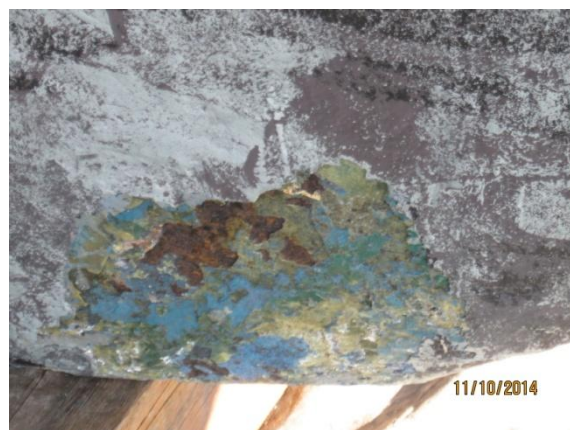
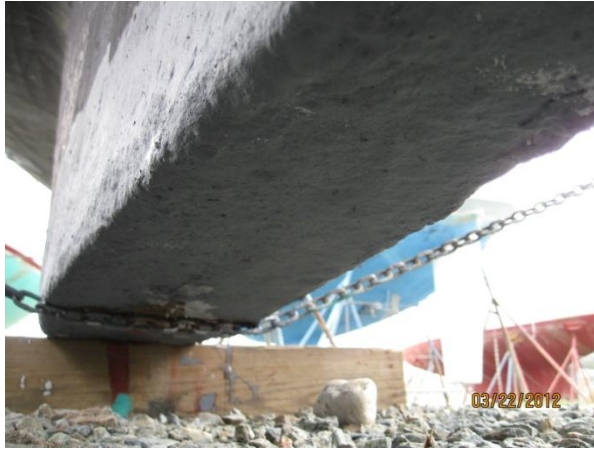
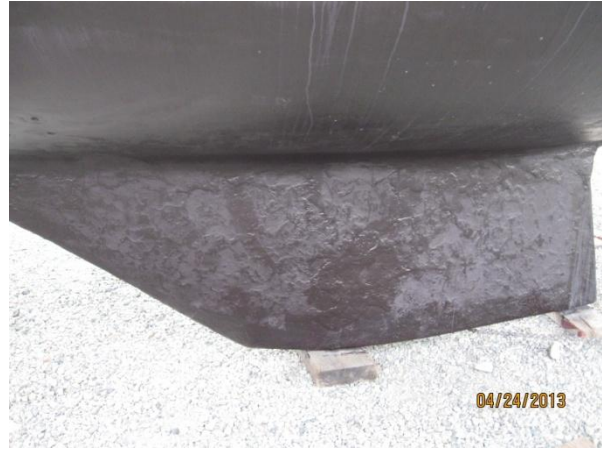
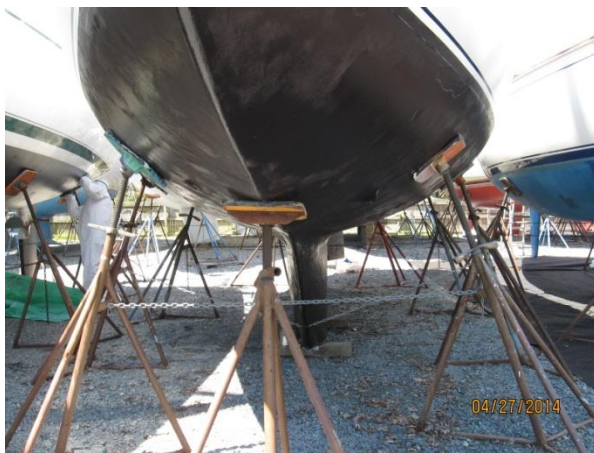
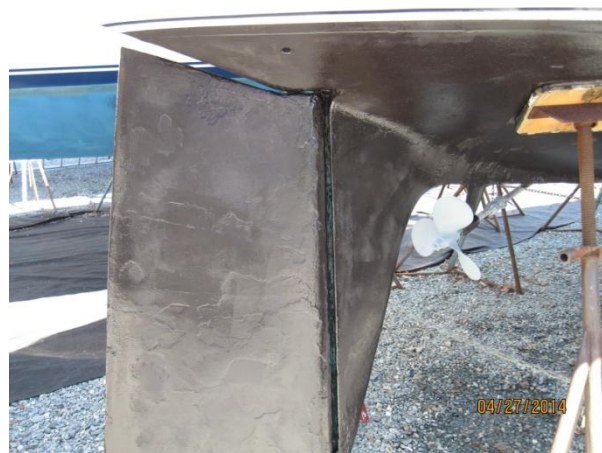
We have hauled our boat out of the water every fall and re-launched it in the spring since 1993. I maintained the bottom each year by sanding it and applying Pettit Trinidad SR bottom paint. Occasionally, I had to sand down to iron and apply Pettit RustLok; then a layer of Pettit Protect barrier coat paint. I had switched to Pettit Ultima SR-40 ablative bottom paint in recent years to reduce the amount of sanding required. Copper and iron don't get along well in salt water; and so I used fiberglass resin and barrier coat paint to shield the iron keel from the cuprous oxide in the bottom paint. Still after 22 years, the iron keel was pretty rough.

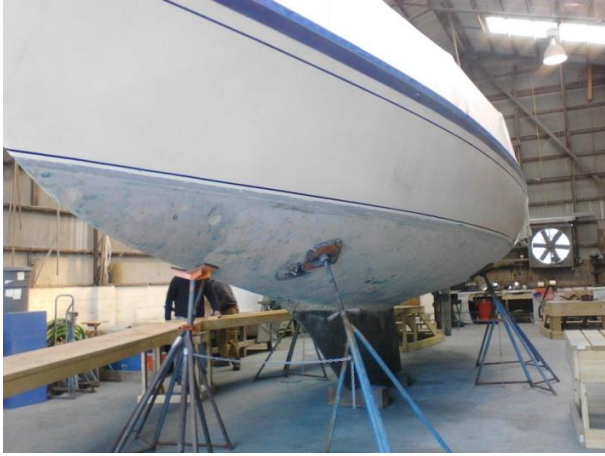
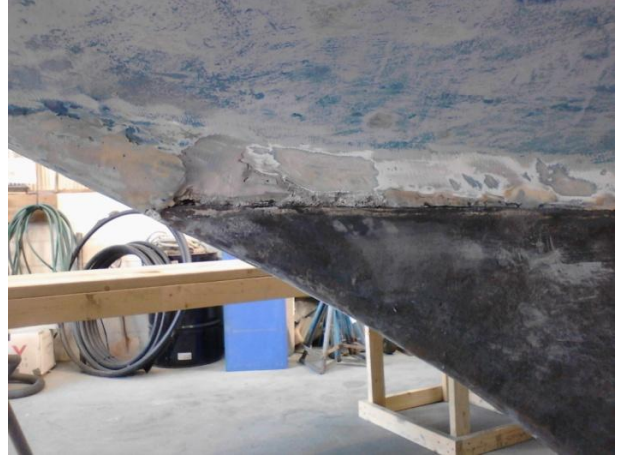
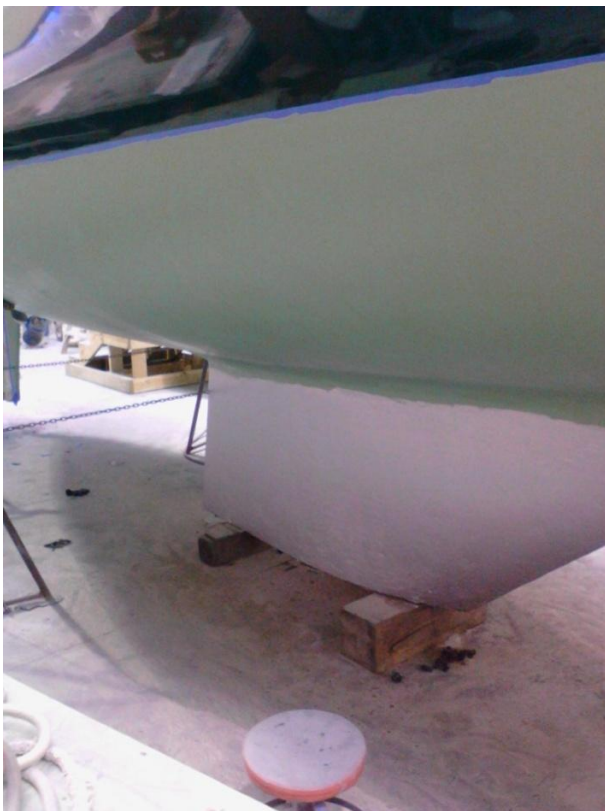
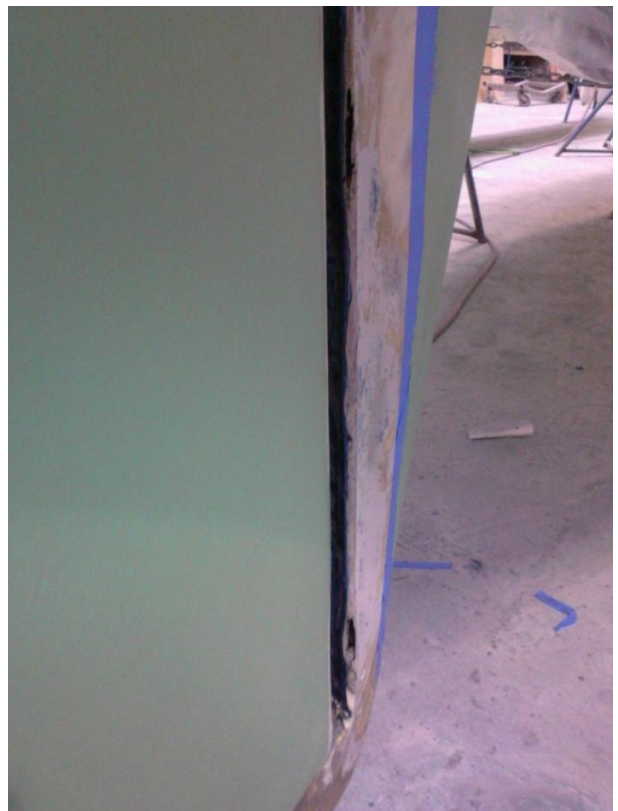
Hull bottom surface appearance can be deceiving. Osmotic blisters were discovered on the hull bottom. Liquid was seeping from them. It was decided to grind all the blisters that could be found, perform fiberglass patch repairs, apply a barrier coat, and bottom paint over the area. The keel-hull junction was cleaned up and sealed with vinyl ester resin and putty. The keel bolts were tight.

Clients were advised of the possibility of additional issues (blisters, etc...) found after or during the removal process. Significant amounts of moisture levels, water intrusion, and blisters were found throughout the bottom and rudder. Failed laminate and coatings were also found on keel. It was advised that a "new" bottom (i.e. remove damaged laminate and replace) would be the proper fix. Clients elected a "patch" option.

Clients were advised that this process will not "fix" issues, just slow down the existing damage, and additional blisters will return. Cannot warranty rudder, hull, or keel joint due to the same issues.

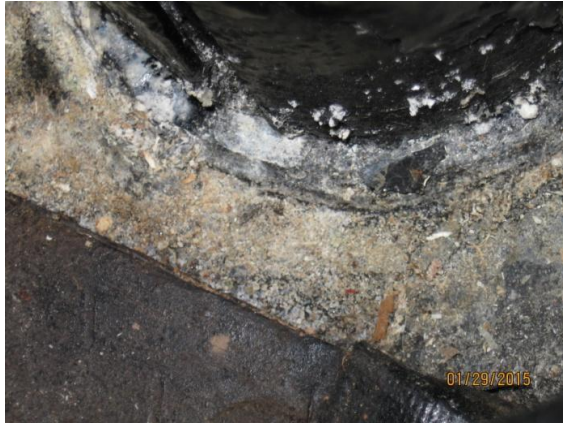
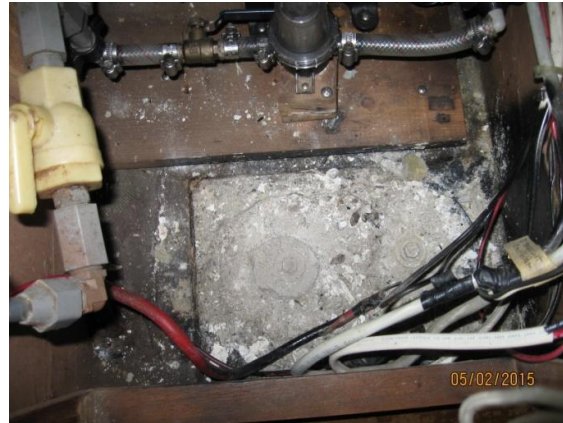
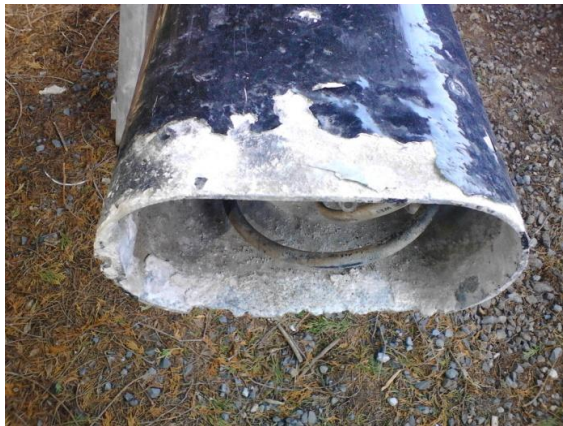
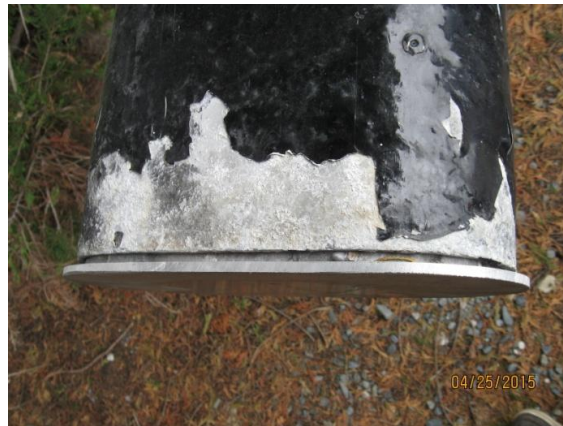
The rudder support needed patching. Vinyl ester resin putty with adhesive filler was used to fill in the small voids.

Two unused seacocks were removed and glassed over from both sides of the hull.

The mast base had corroded and fused with the step plate. A new aluminum plate had to be fabricated.

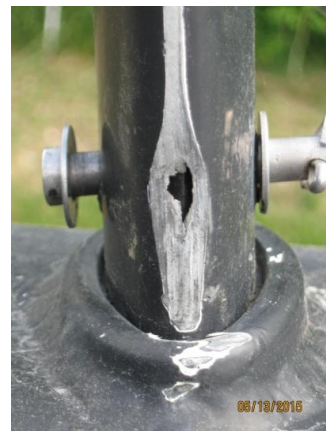
An inspection of the top of the mast disclosed wear on the upper starboard spreader and a missing wind vane.

The wear on the spreader arm next to the mast was assessed to result from attaching the main halyard, when not in use, to the starboard shroud at a cable cleat. The main halyard cable had worn a hole on the aft side of the spreader caused by the wind blowing the halyard against the spreader. The hole was filled with JB Weld 2-part epoxy. I changed the main halyard "idle" attachment point to the boom in order to prevent further wear.

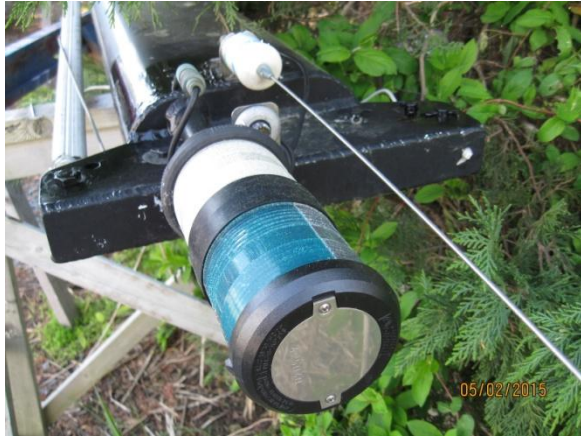
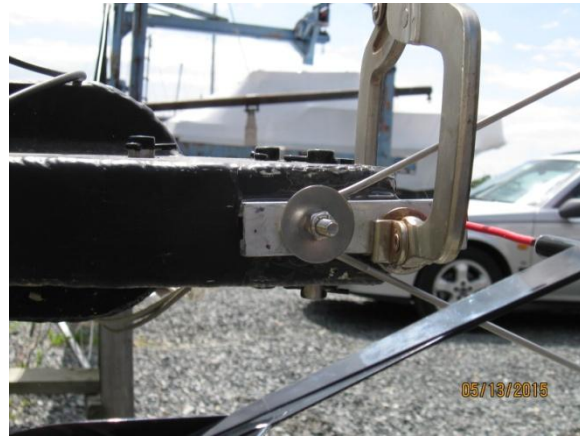
When the mast was unstepped, the wind vane mount was knocked off the mast near the VHF antenna. An aluminum extrusion was fabricated and attached to the mast cross-arm using JB Weld 2-part epoxy. A 15 inch long wind vane was attached at the end of the extrusion. The offset enabled the vane to swing clearly through 360 degrees, missing the VHF antenna.
